Value Plus Home Inspections, Inc.

SUMMARY REPORT

Client: Claire & Scott Noyes
Realtor: Carolyn Basham, Homes Your Way
Inspection Address: 921 De Witt St, Panama City, Florida 32404
Inspection Date: 07/29/2005 Start: 8:45 am End: 1:00 pm
Inspected by: David Bowers

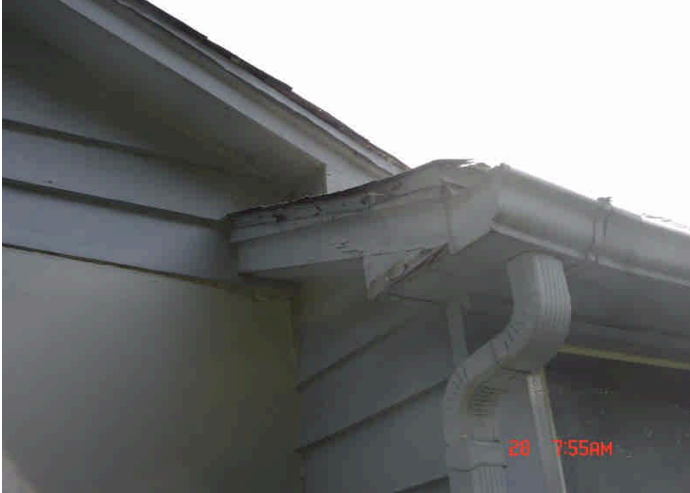
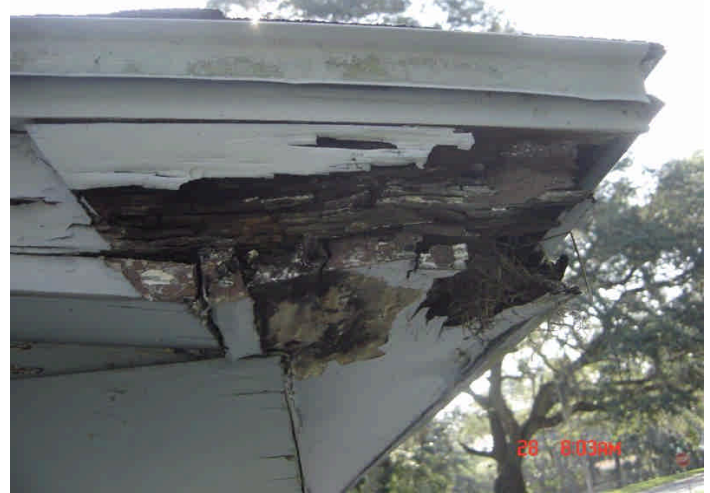
There is moisture damage to the fascia, eave, and wood trim that should be evaluated by a termite inspector. The moisture damaged areas of the fascia, eave, and wood trim will need repair or replacement by a licensed contractor.

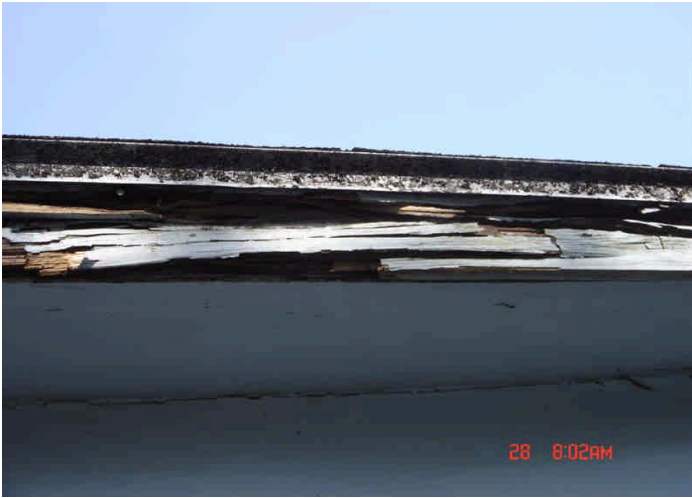
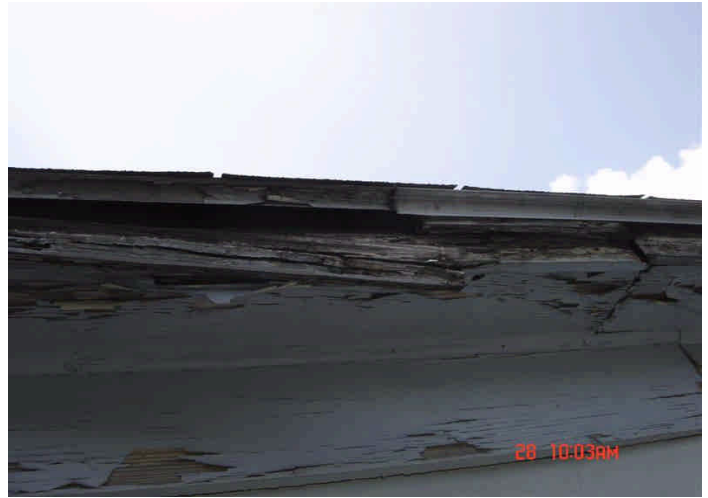
The window-trim, and particularly that on the south facing side that is exposed to direct sunlight, is in poor condition and needs to be serviced.

There are window panes with broken hermetic seals at the main entry, which should be replaced.

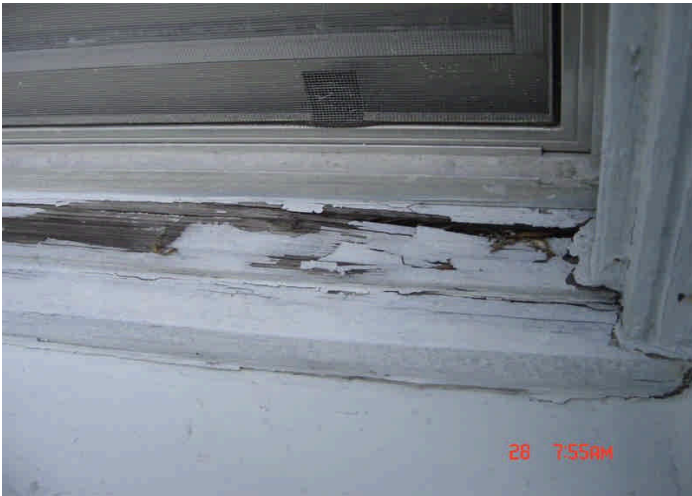
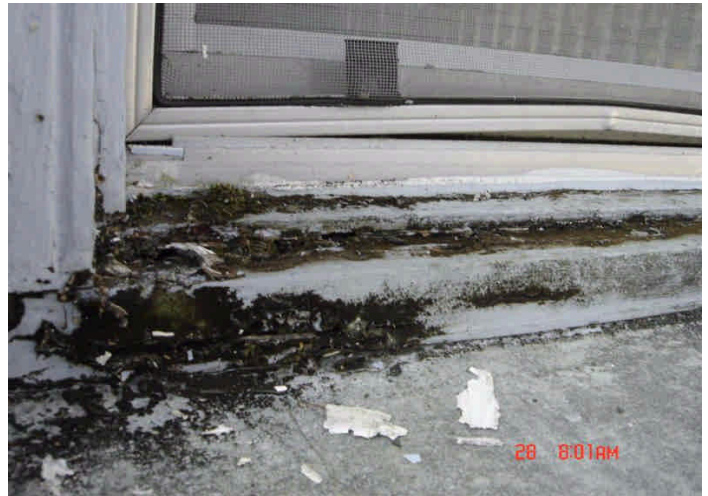
The single hung window sills have wood rot that will need evaluation and replacement by a licensed contractor who may find additional defects if the moisture has penetrated the walls and damaged the framing.

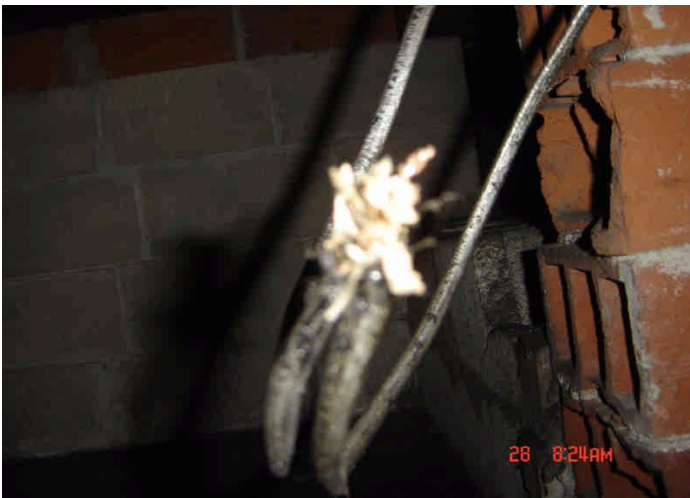
An electrical connection within the crawlspace has been incorrectly made outside of a junction box, which is a potential fire-hazard. All such connections should be made inside a junction box, in order to contain any arcing or sparking within the box.

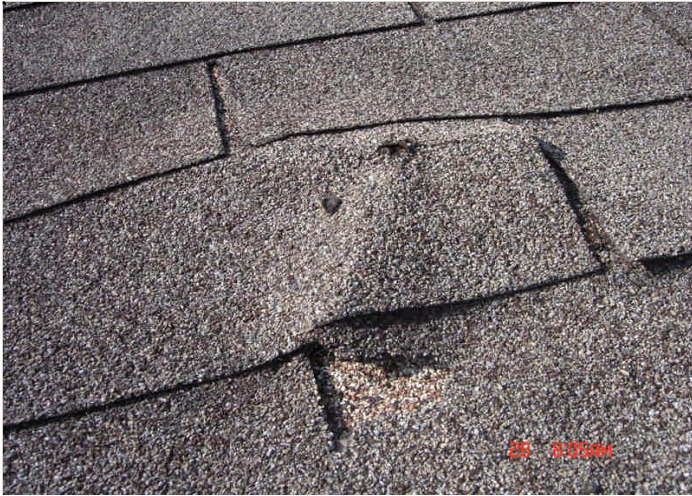
The roof is in the primary stages of decomposition, which means that the roof is in decline and susceptible to leaks. It will need to be maintained and closely monitored, because it is reaching the end of its serviceable life, and you may wish to have a second opinion before the close of escrow. There is a nail pop that you should have repaired by a licensed roofing contractor.

There are moisture stains and moisture damaged decking that should be evaluated and repaired or replaced by a licensed roofing contractor. There was no current moisture in and around the stains. You may want to seek a second opinion from a roofing contractor who can give a roofing guarantee with a water test.

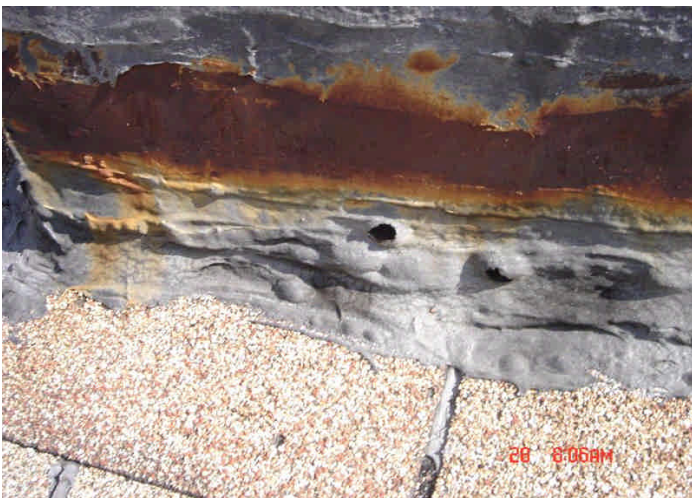
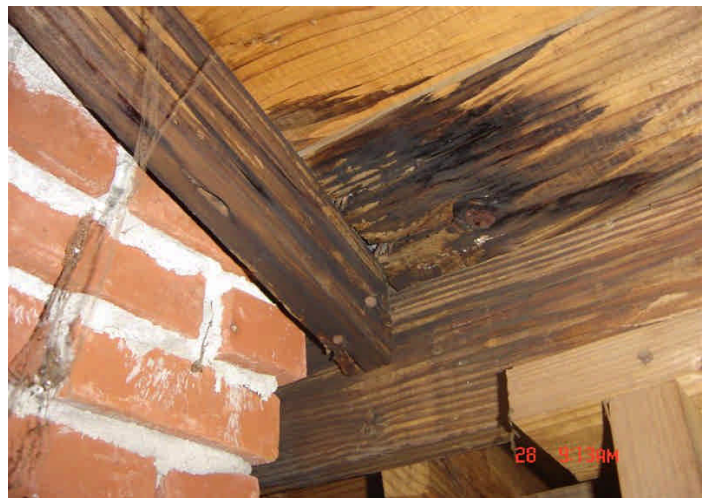
The chimney flashings need to be resealed. The mastic seal should be resealed every 2-3 years or as needed. The decking under the chimney area has some moisture stains and minor rot that should be replaced when the roof is replaced.

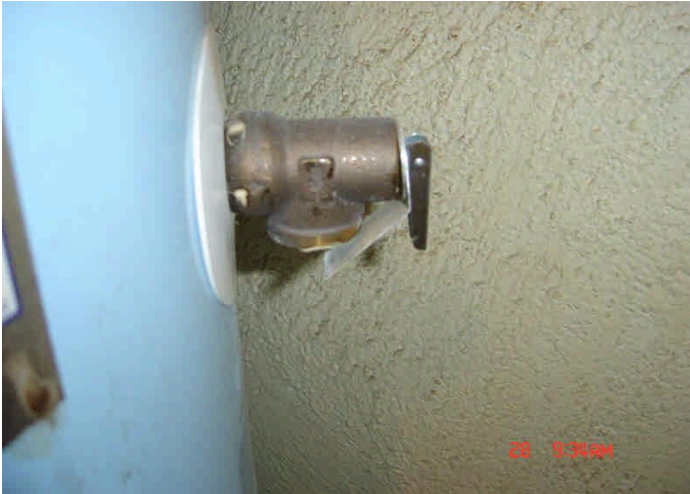
The pressure relief valve on the water heater does not have a discharge pipe. One should be installed that terminates approximately six inches above grade.

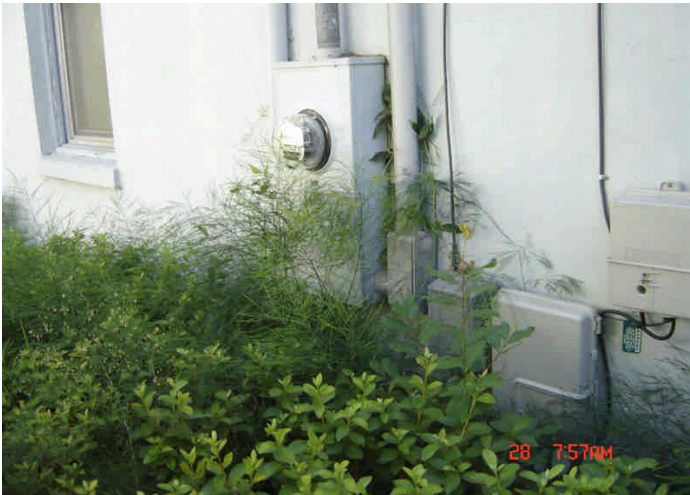
The panel does not have thirty-six inches of clear space in front of it to facilitate an emergency disconnect, a condition which should be corrected.

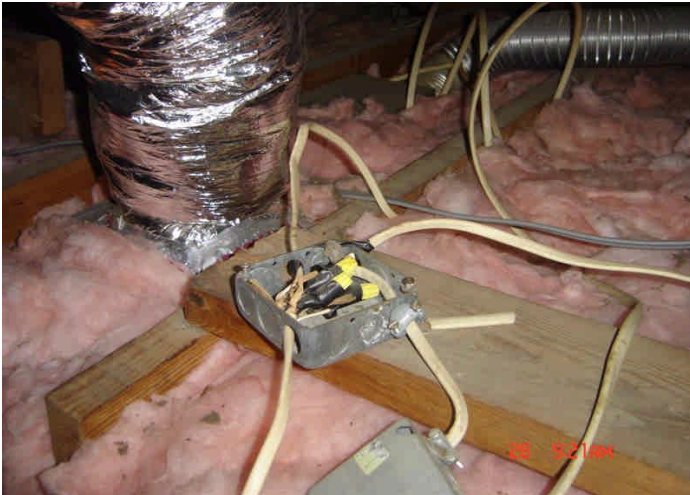
There is an open electrical junction box, which should be sealed so that any arcing or sparking would be contained within the box.

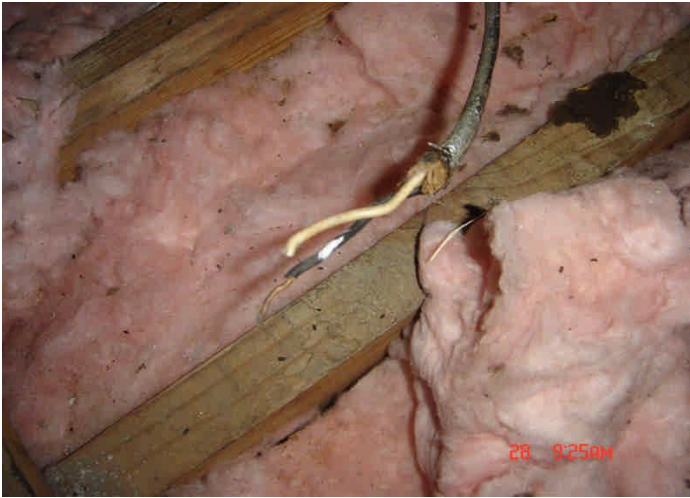
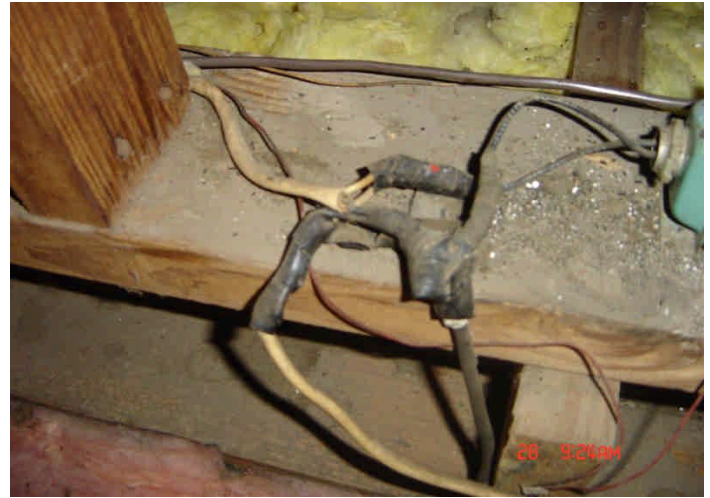
Several electrical connections have been incorrectly made outside of junction boxes. All such connections should be made within junction boxes in order to contain any arcing or sparking that could occur, a task that should be completed by a licensed electrician.
